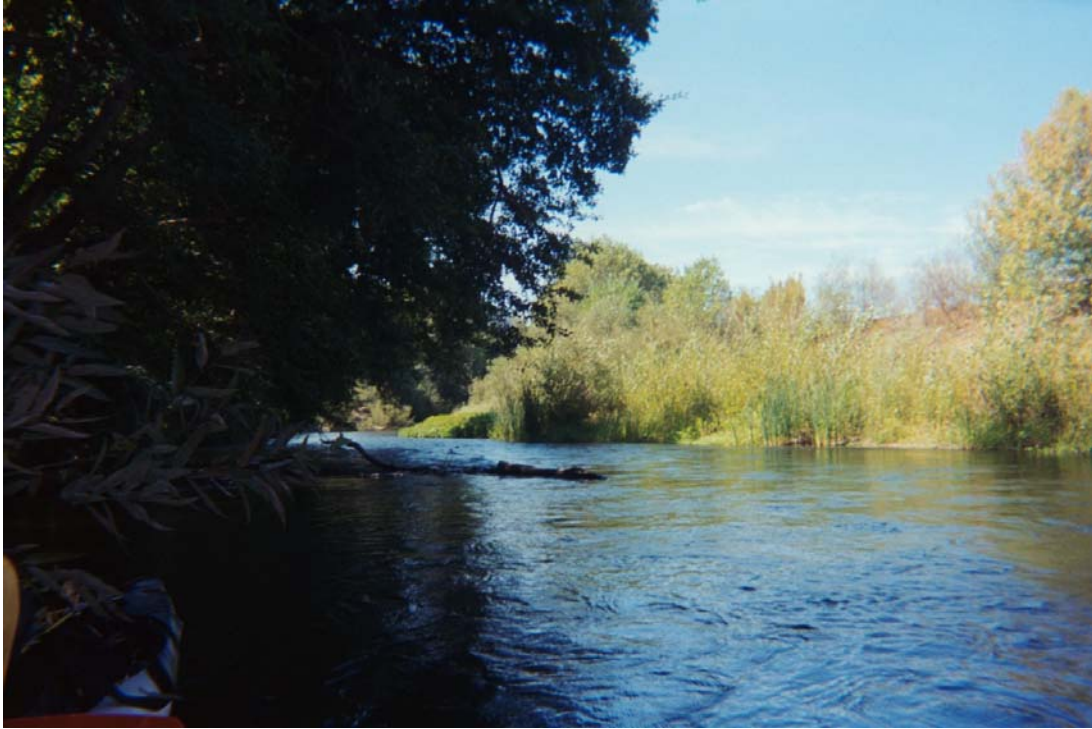
Figure 17: Ukiah Reach, Segment U12. This segment contained moderately fast-moving flatwater habitat. No steelhead were observed.

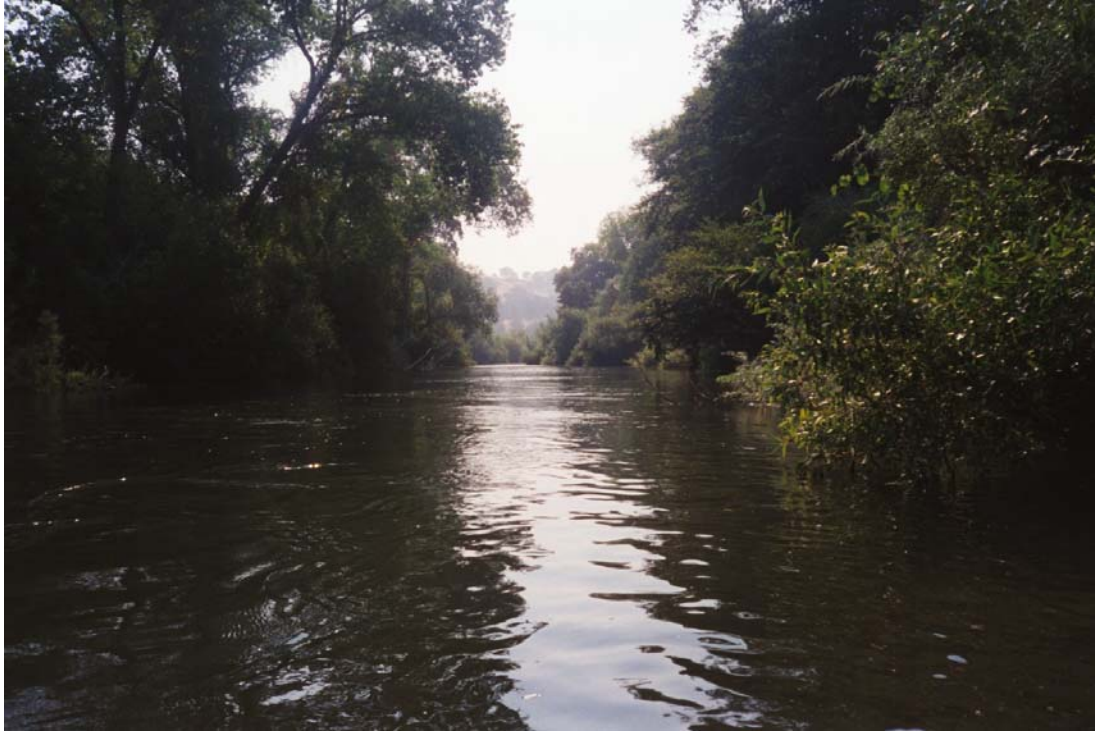
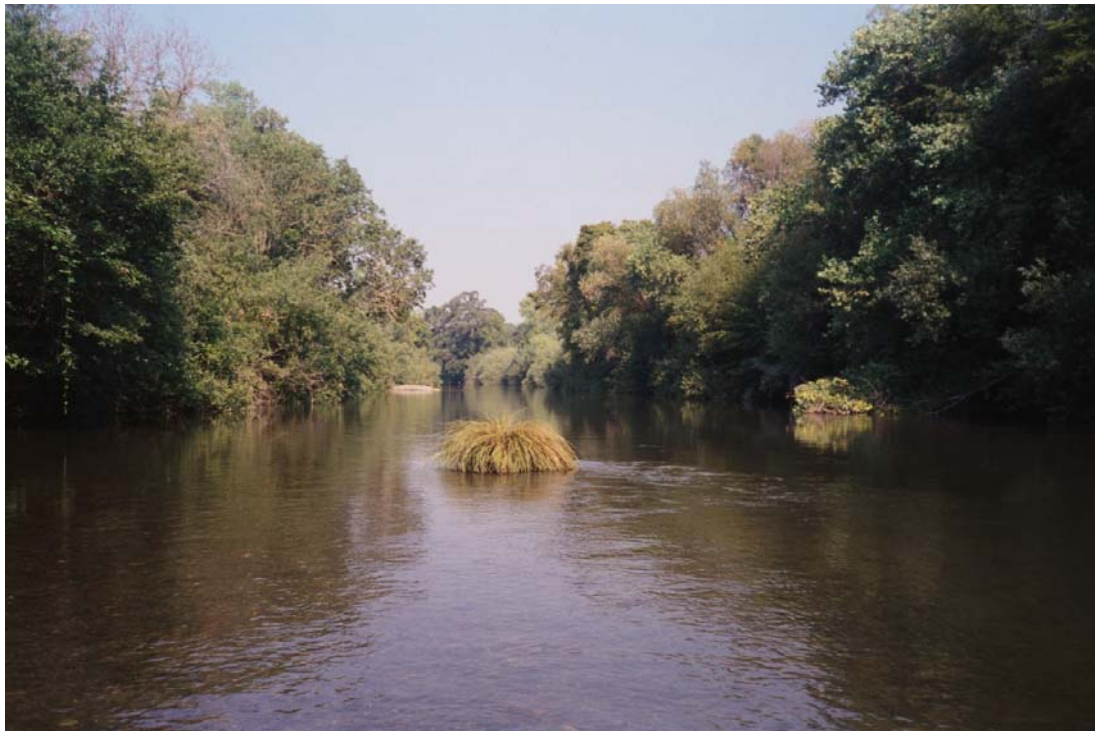
Figure 18: Canyon Reach, Segment C1. This segment contained flatwater habitat with well-developed riparian cover on both banks of the river. No steelhead were observed.

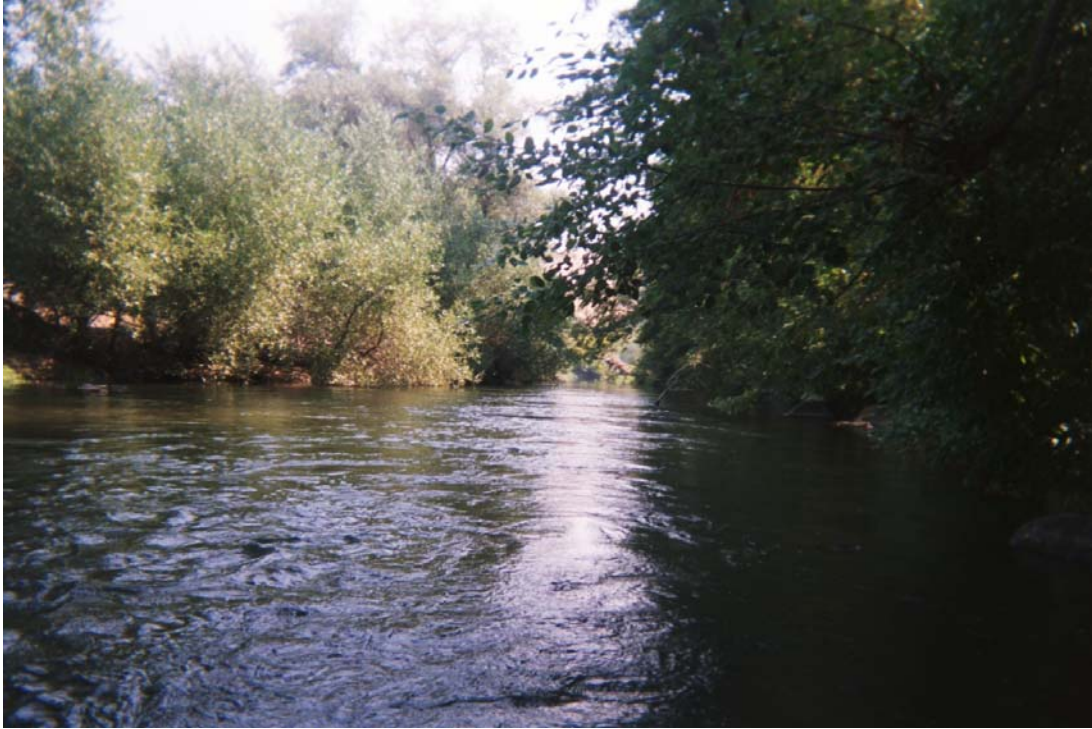
Figure 19: Canyon Reach, Segment C2. This segment contained flatwater habitat with well-developed riparian cover. Steelhead were observed in low numbers ($n=12$) in this segment and was the upstream limit for steelhead in the Canyon Reach.

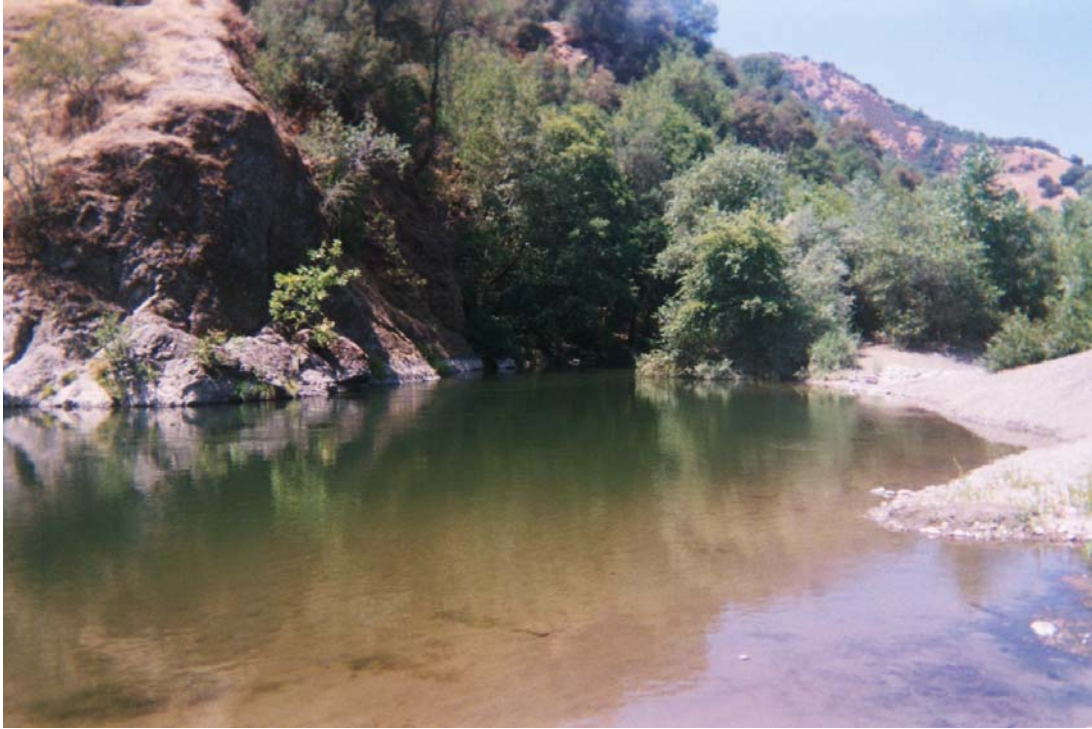
Figure 20: Canyon Reach, Segment C3. This segment consisted of 99% flatwater and 1% deep pool. The deep pool, shown in the photograph, was formed in a bend with bedrock substrate. Steelhead were observed in low numbers ($n=5$).

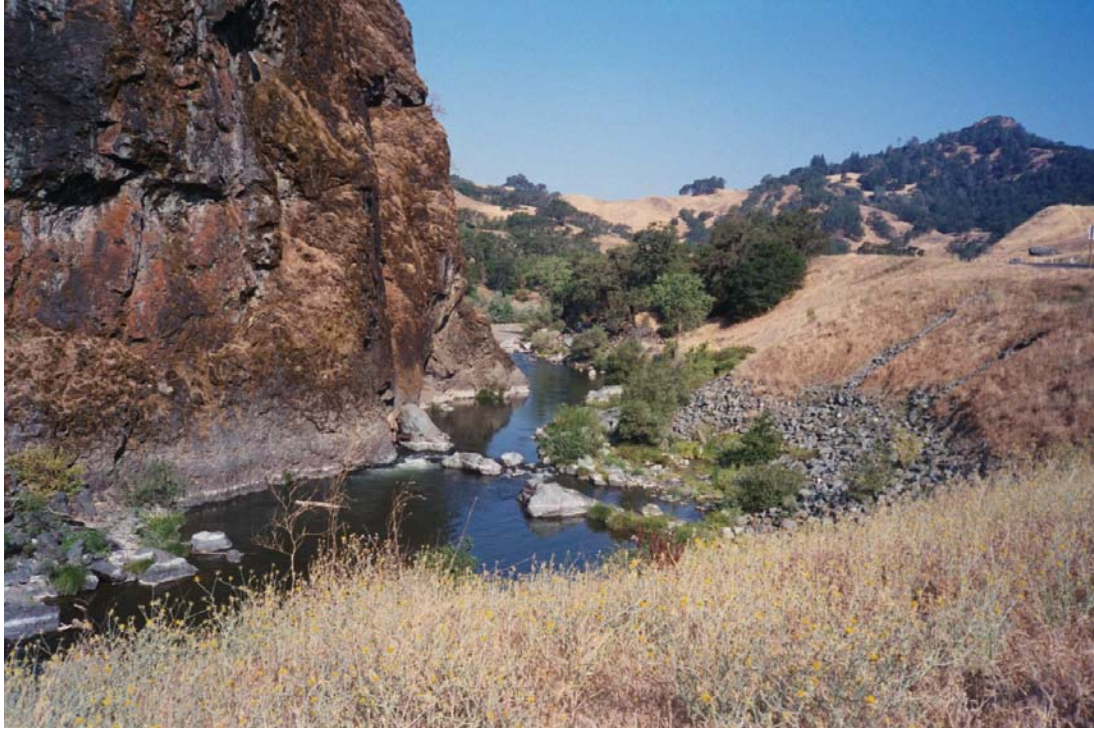
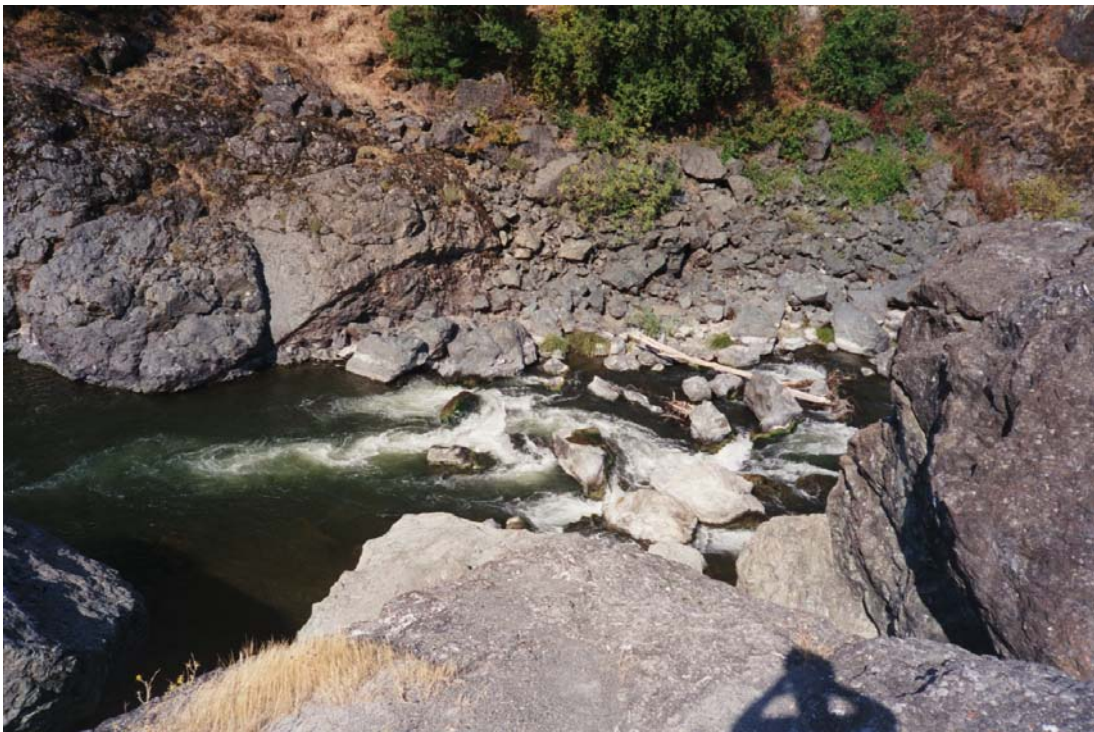
Figure 21: Canyon Reach, Segment C4. A total of 113 steelhead were observed in this segment, primarily in cascade and riffle habitats. The fast-flowing cascade shown in the bottom photograph had 74 steelhead observations.
